Dewatering for the Repair of Leaking Serpentine Trunk Water Mains

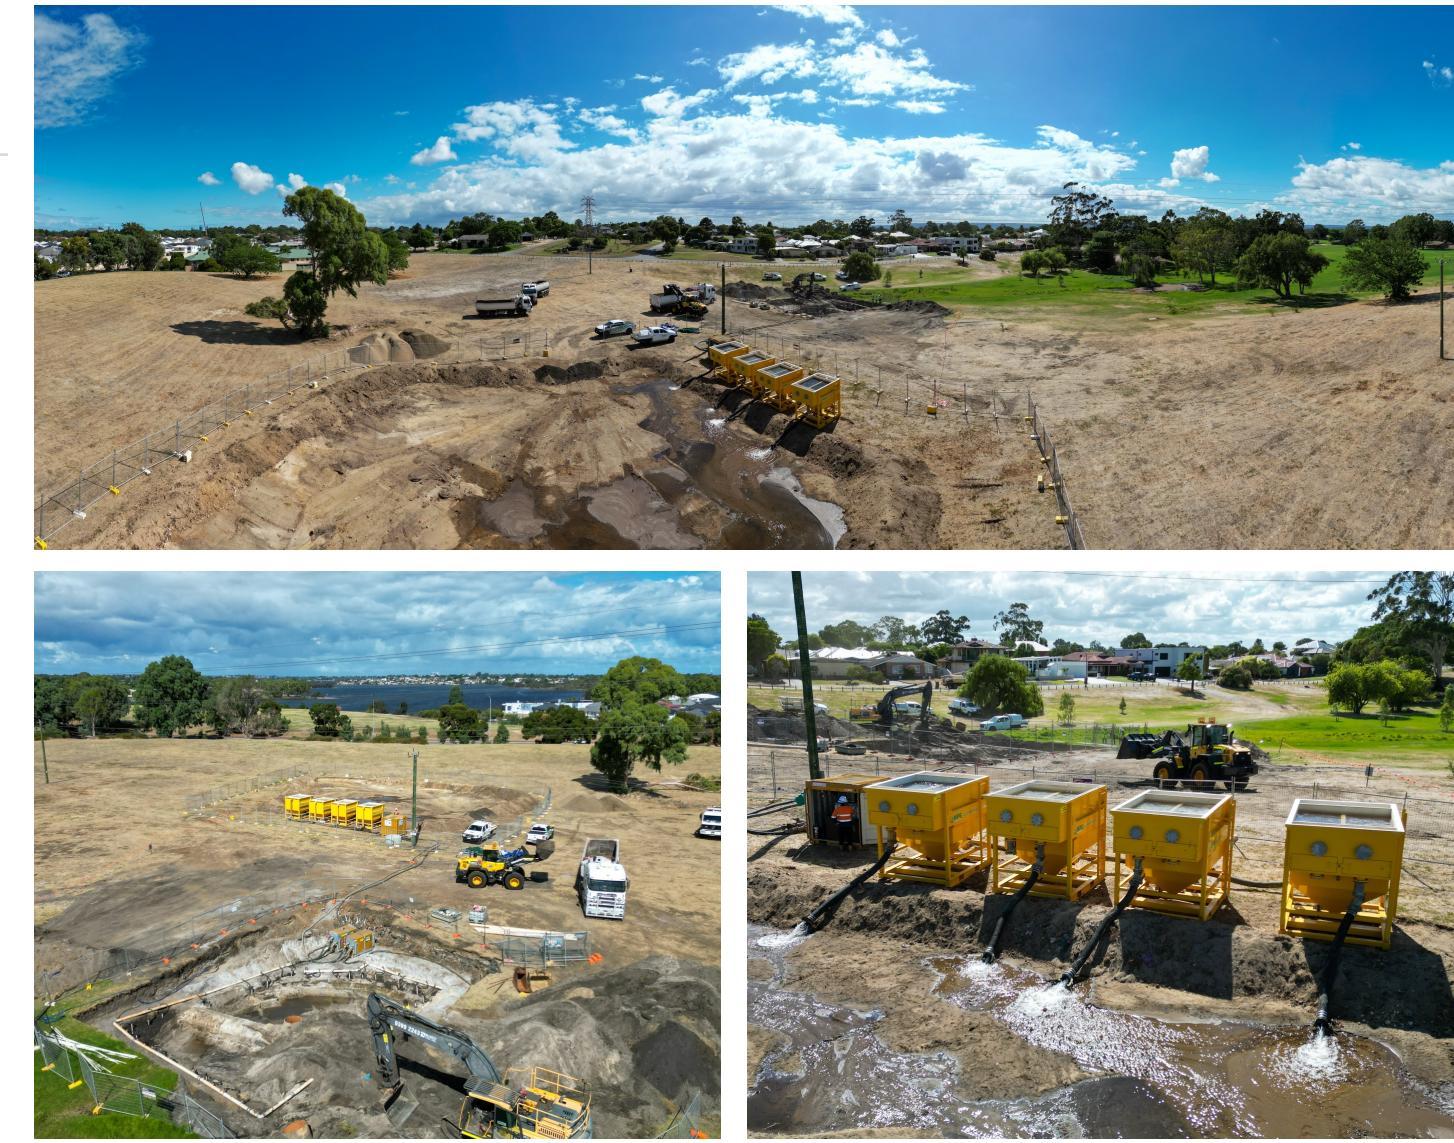
The project entails conducting excavation works at a depth of 6 meters below ground level. To facilitate repair efforts, it is essential to effectively dewater the site, manage discharge effluent, and address any unexpected changes in ground conditions that may arise. Throughout the project, environmental monitoring and reporting compliance will be strictly maintained to ensure adherence to all regulatory requirements.

The project achieved a successful aquifer drawdown, effectively managing water ingress at a rate of 30 litres per second. Ongoing environmental monitoring ensured that the project adhered to regulations, with treated water approved for discharge into the onsite designated infiltration basin. The estimated three days of pumping required to reach manageable aquifer levels were adhered to, allowing construction crews to proceed with the repairs without significant delays.
